# TOPOGRAPHIC SURVEY

SW 1/4 NE 1/4 SEC. 30  
TOWNSHIP 25 NORTH, RANGE 6 EAST W.M.  
KING COUNTY, WASHINGTON

**Document Title:** Variance Application (Project Description and Code Compliance Narrative)

**GEOTECHNICAL ENGINEERING STUDY  
PROPOSED SINGLE-FAMILY RESIDENCE RECONSTRUCTION  
1472 WEST LAKE SAMMAMISH PARKWAY NORTHEAST  
BELLEVUE, WASHINGTON**

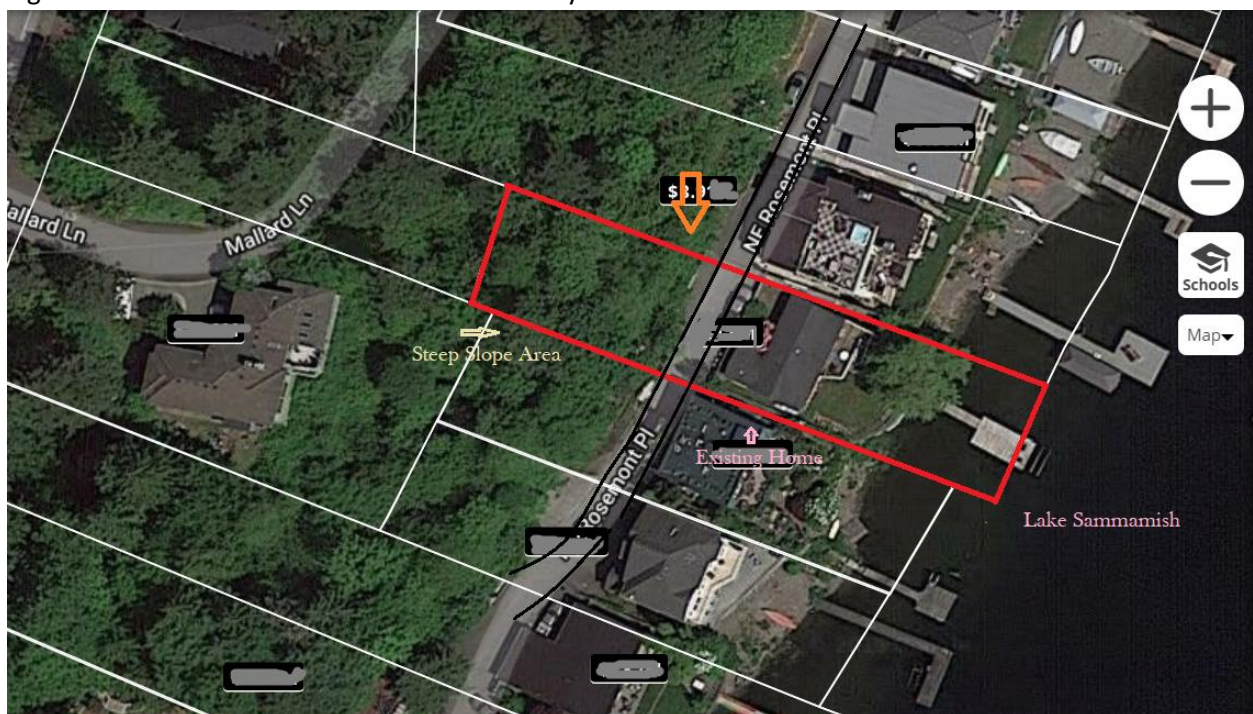
Figure 1 – 1472 West Lake Sammamish Parkway NE

The property owner is proposing redevelopment of the property and is requesting approval to build a new larger single-family home in the place of the current home between the access driveway, and the shoreline of Lake Sammamish. See Figure 1 below:

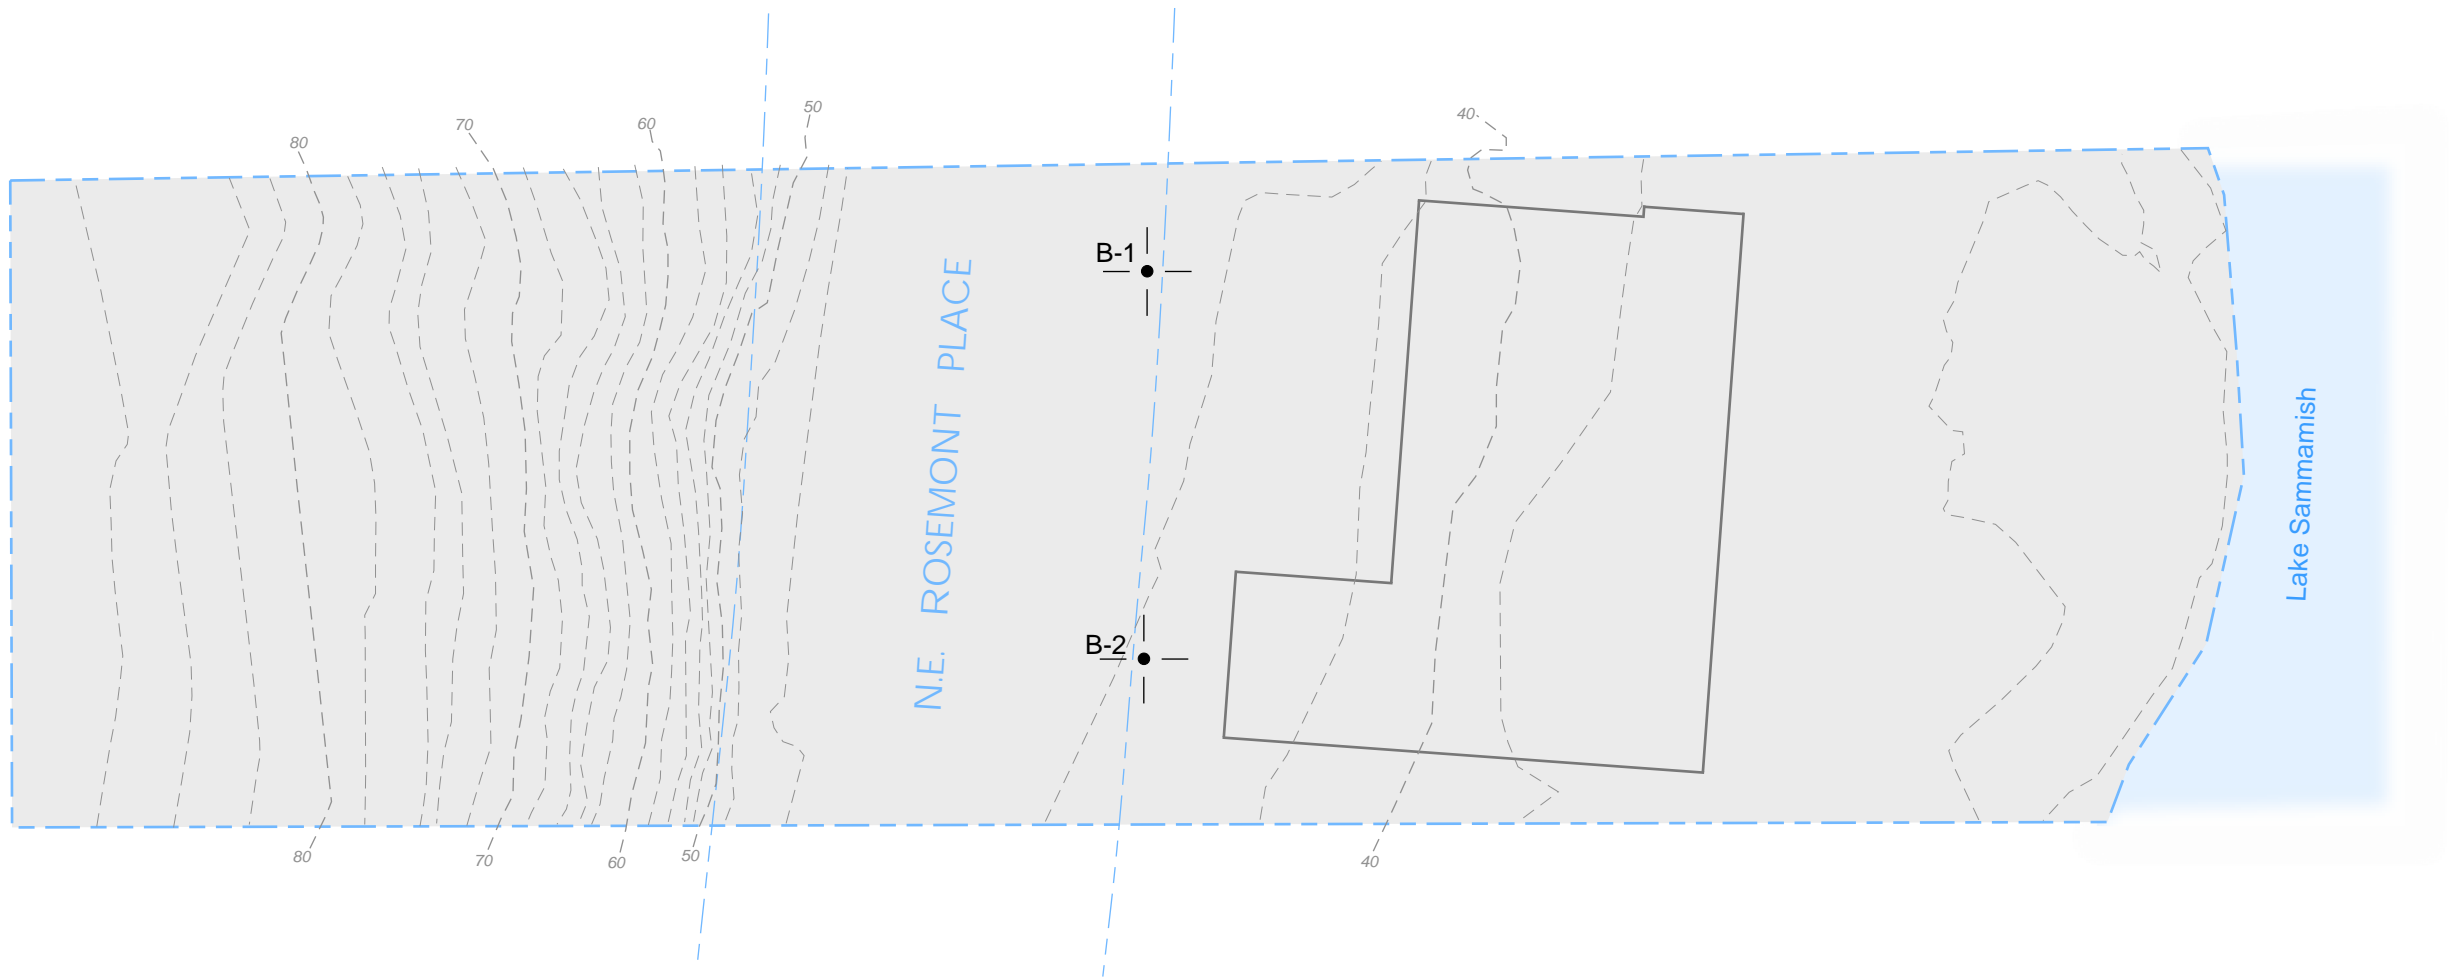
NOTE: The graphics shown on this plate are not intended for design purposes or precise scale measurements, but only to illustrate the approximate test locations relative to the approximate locations of existing and / or proposed site features. The information illustrated is largely based on data provided by the client at the time of our study. ESNW cannot be responsible for subsequent design changes or interpretation of the data by others.

- B-1 | — • — | Approximate Location of ESNW Boring, Proj. No. ES-6876, Sept. 2019
- [Dashed Blue Outline] Subject Site
- [Solid Black Outline] Existing Building

An ESNW representative observed, logged, and sampled two borings on September 6, 2019. The borings were advanced using a limited-access drill rig and operators retained by our firm. The borings were completed to evaluate soil and groundwater conditions as near as possible to the proposed reconstruction area. The approximate locations of the borings are depicted on Plate 2 (Boring Location Plan). Please refer to the boring logs provided in Appendix A for a more detailed description of subsurface conditions. Representative soil samples collected at the boring locations were analyzed in general accordance with both Unified Soil Classification System (USCS) and USDA methods and procedures.

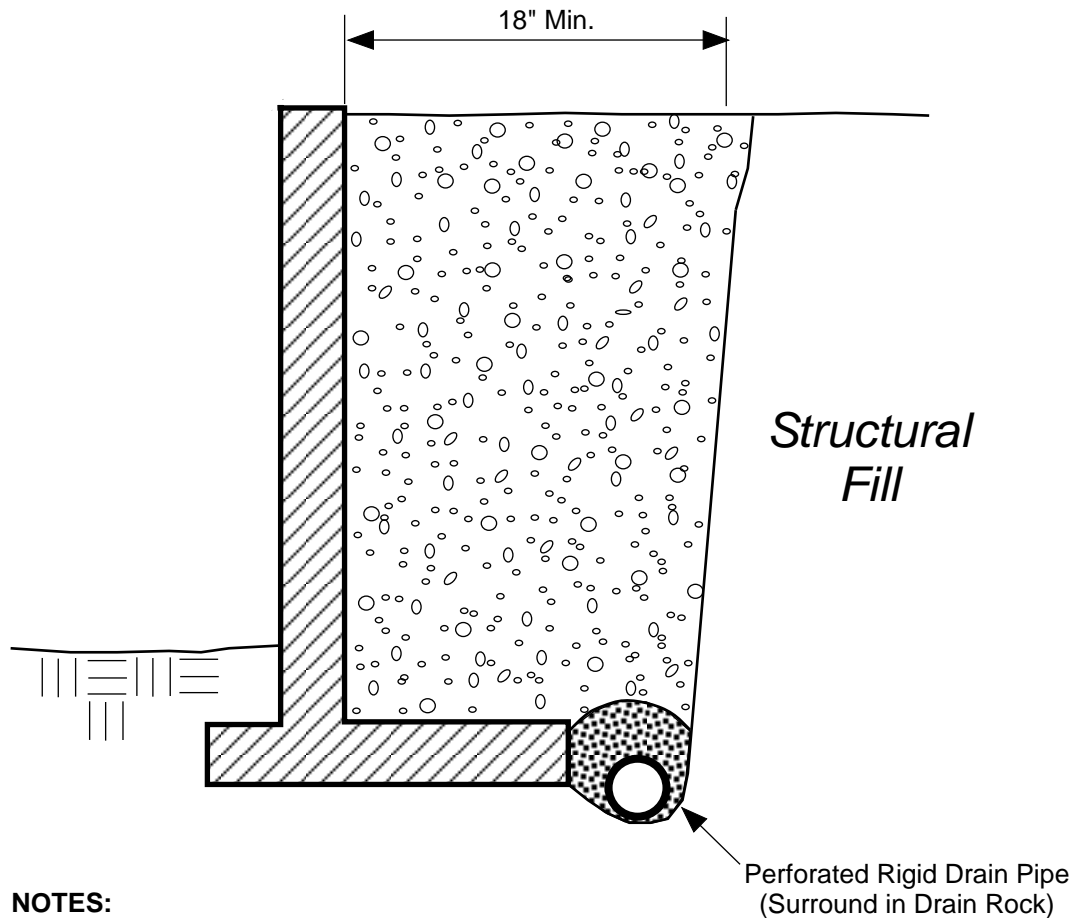
**NOTES:**

- Free-draining Backfill should consist of soil having less than 5 percent fines. Percent passing No. 4 sieve should be 25 to 75 percent.
- Sheet Drain may be feasible in lieu of Free-draining Backfill, per ESNW recommendations.
- Drain Pipe should consist of perforated, rigid PVC Pipe surrounded with 1-inch Drain Rock.

1-inch Drain Rock

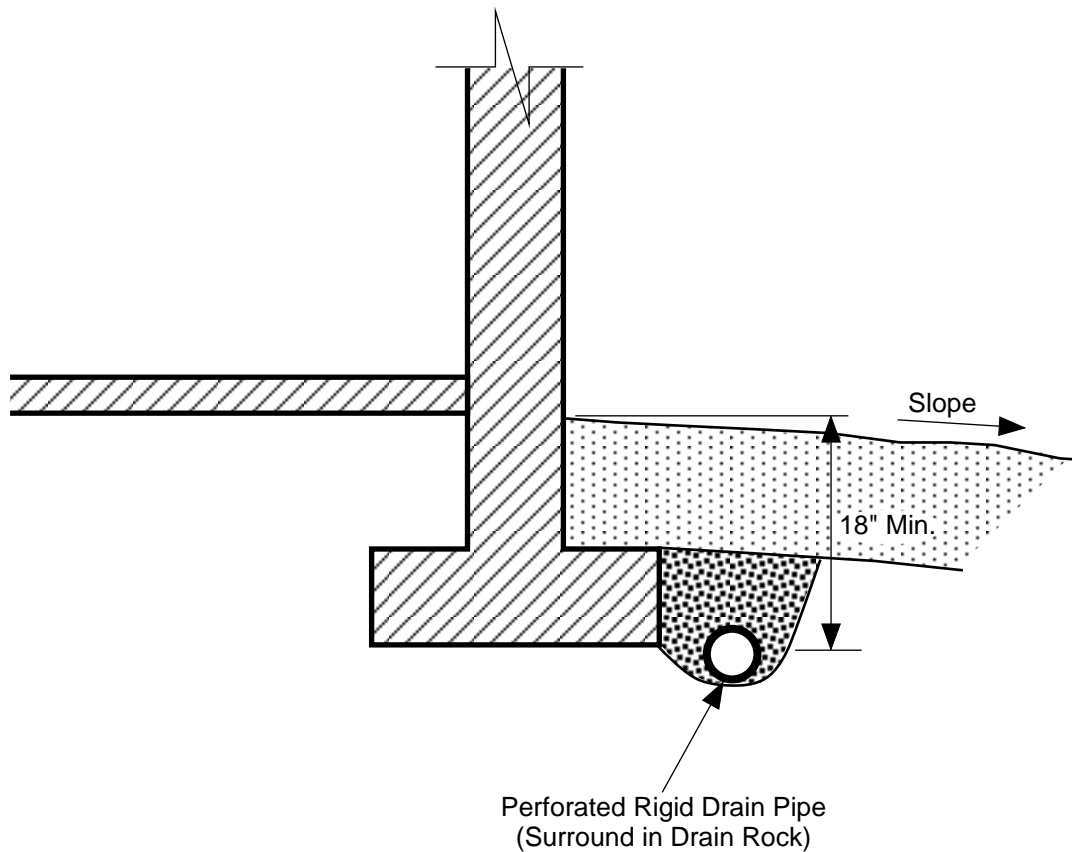
**NOTES:**

- Do NOT tie roof downspouts to Footing Drain.
- Surface Seal to consist of 12" of less permeable, suitable soil. Slope away from building.

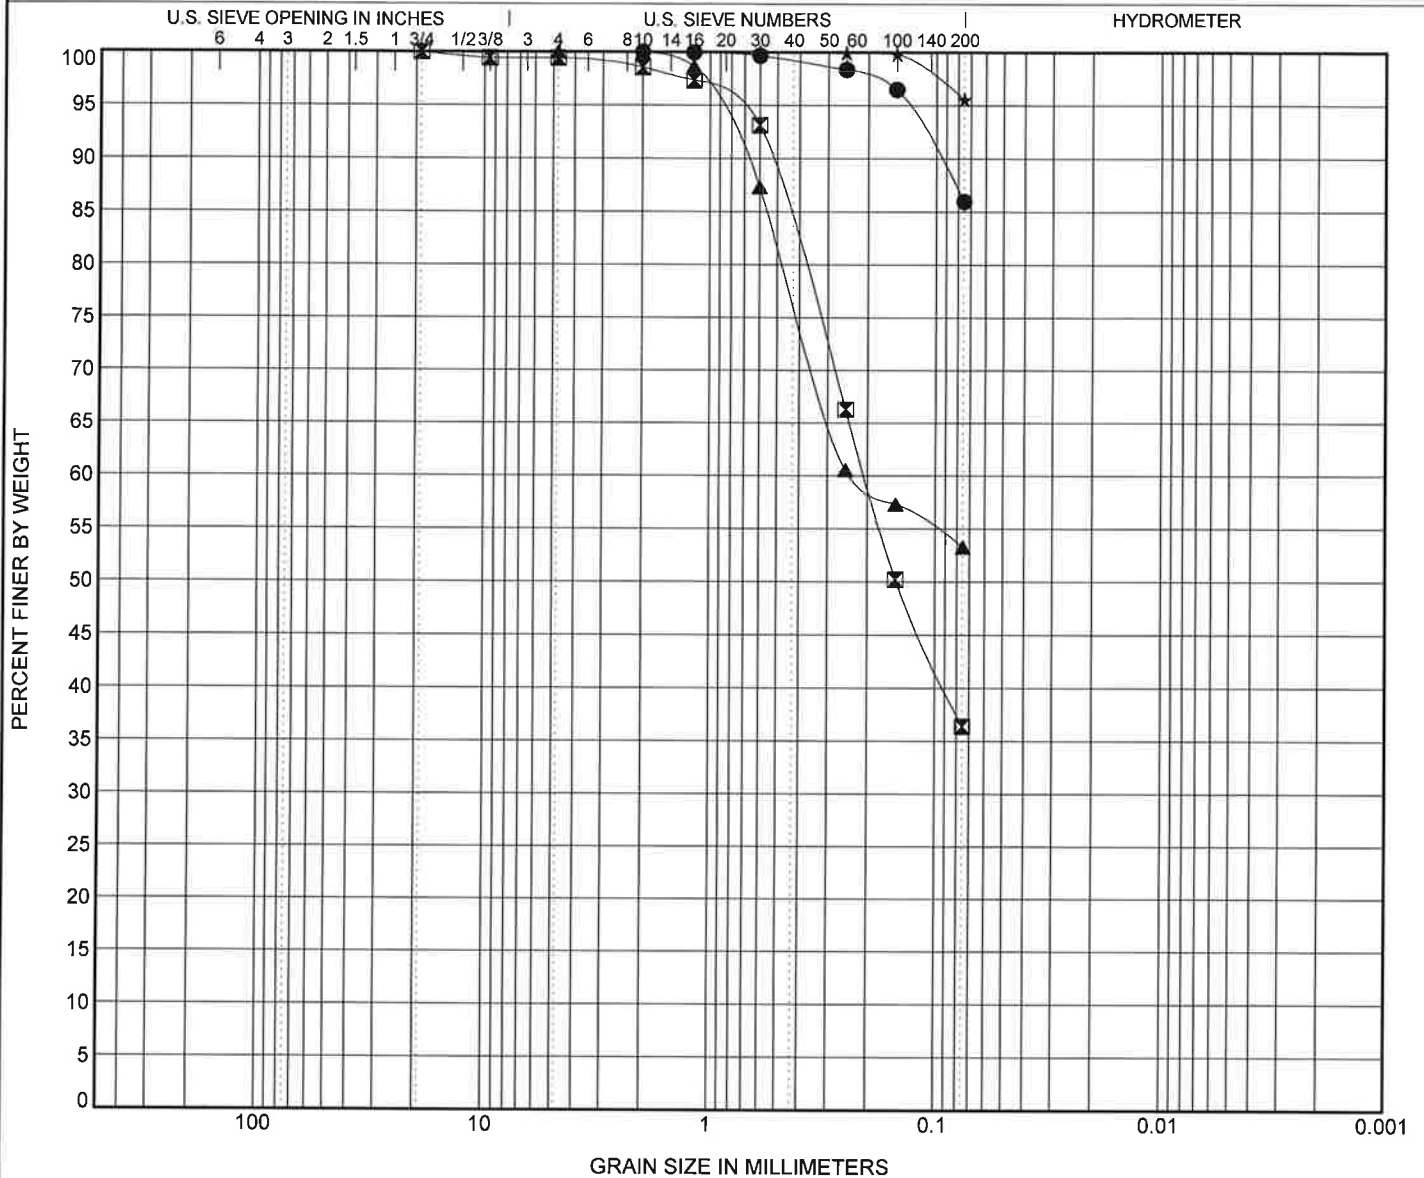
COBBLES	GRAVEL		SAND			SILT OR CLAY
	coarse	fine	coarse	medium	fine

Specimen Identification			Classification							Cc	Cu
●	TP-01	6.00ft.	USDA: Gray Loam. USCS: ML.								
☒	TP-02	2.50ft.	USDA: Gray Slightly Gravelly Sandy Loam. USCS: SM.								
▲	TP-02	7.50ft.	USDA: Gray Slightly Gravelly Loam. USCS: Sandy ML.								
★	TP-02	15.00ft.	USDA: Gray Loam. USCS: ML.								
Specimen Identification			D100	D60	D30	D10	LL	PL	PI	%Silt	%Clay
●	TP-01	6.0ft.	2							86.0	
☒	TP-02	2.5ft.	19	0.205						36.4	
▲	TP-02	7.5ft.	4.75	0.23						53.3	
★	TP-02	15.0ft.	1.18							95.5

Underlying about 8 to 10 inches of asphalt and crushed rock fill, the native soil was comprised of silty sand and sandy silt (USCS: SM and ML, respectively). The native soil density was very loose until a depth of about five feet below the existing ground surface (bgs), becoming medium dense until about seven feet bgs, and thereafter remaining dense to the termini of the boreholes. The native soil was reported primarily as "wet" at the time of the exploration, and the maximum exploration depth was about 16.5 feet bgs.

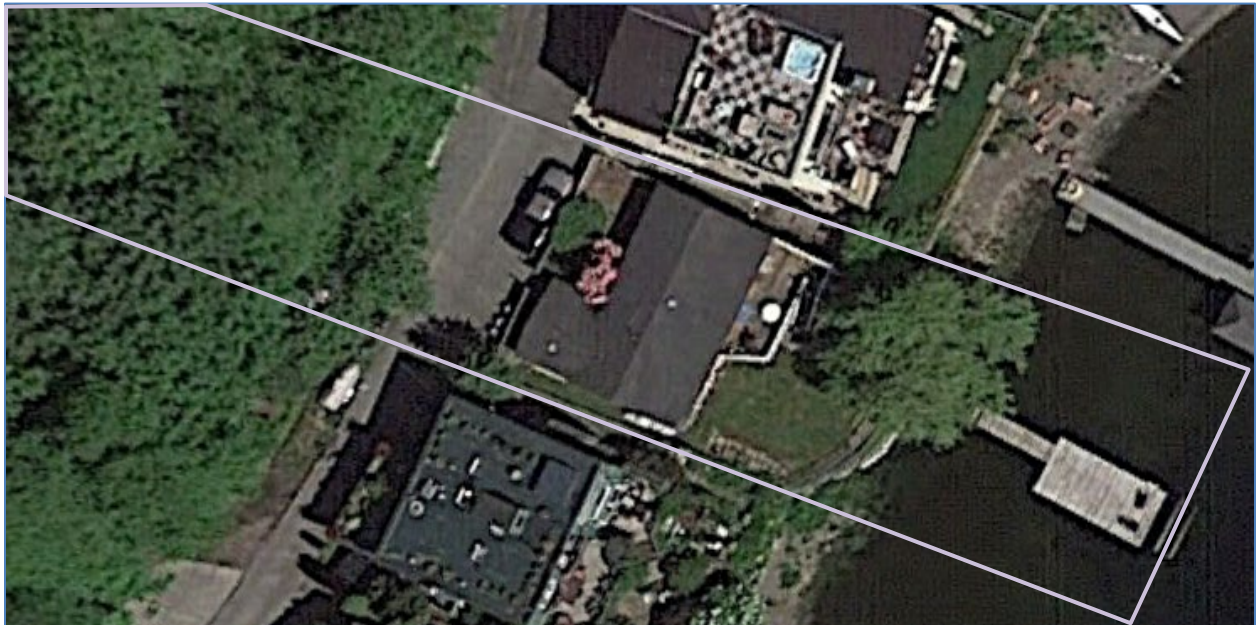
**Figure 1.** Li property on Lake Sammamish.

An existing home located at 1472 West Lake Sammamish Parkway NE (Figure 1) will be razed and replaced with an all new structure. The new structure will be located outside of the 25-foot Lake Sammamish buffer, and landward of an existing, legally established retaining wall. All proposed work will be approximately 5-feet and higher above the ordinary high-water mark (OHWM) of 31.8 feet elevation used by the City of Bellevue as a regulatory line from which to measure buffers for Lake Sammamish. No work is proposed within the Lake Sammamish floodplain (elevation 36.1 feet). Both the existing and proposed homes are located entirely within the Shoreline Management Area (SMA). There is no developable land on the lot that is not within the SMA. No native vegetation will be disturbed, and no other critical areas or habitat will be affected by the proposed action.

The remainder of the Lake Sammamish buffer upland of the retaining wall consists of lawn (Figure 2), a few landscaping areas, a three foot-wide at-grade concrete walkway, and a staircase up to the deck. The floodplain elevation of 36.1 feet is located about halfway up to the house. The existing house extends from the lawn/patio back about 50 feet to the access road (NE Rosemont Place). A well-vegetated steep slope extends from the road past the limits of the Shoreline Management Area (Figure 1).

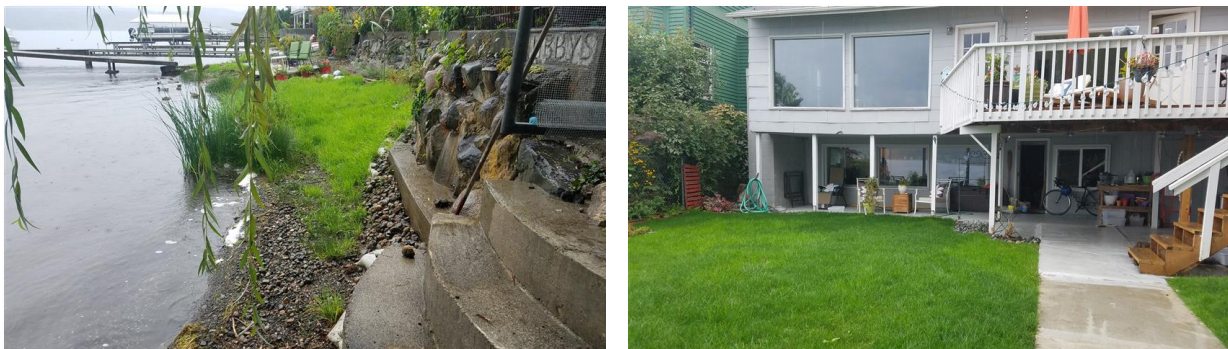
**Figure 2.** Shoreline conditions on beach (left) and above retaining wall (right) (September 2019).

A concrete retaining wall located near the OHWM line extends across the property and ranges from three to four feet in height above the beach (Figure 2). The landscape below the retaining wall consists primarily of a gravel beach sloped gently down into the water. There are some plants within this area including weedy grasses and small native forbs. A 3-foot wide concrete path leads from a staircase on the beach up across the buffer to the house (Figure 2). An older wooden dock provides access to the lake.

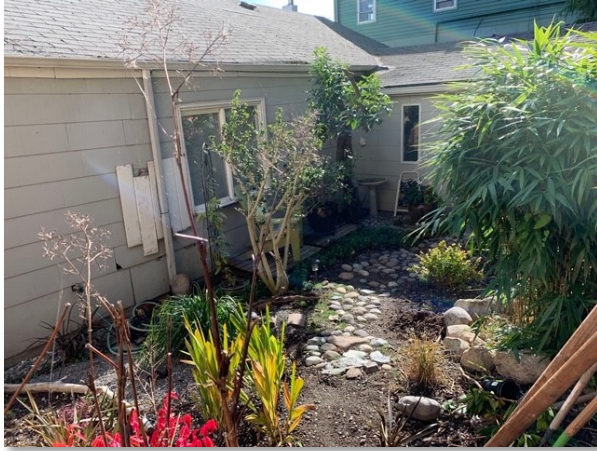
Figure 3 – Existing garden in slope setback.

No work will be completed on the steep slopes found on this site. The steep slope is located on the west side of the access road to the house. The house and all proposed work are located east of the access road. While development is proposed within the steep slope setback, it will occur in an area previously cleared and graded and now used as a garden adjacent to the house (Figure 3). The area provides no support for the slope being flat and on the far side of the access road. Building a house in this area will not affect slope stability (see Geotech Report).
